# 4.3. Water quality trends on test areas (water resources)

Faculty of Civil Engineering University of Rijeka (FB8)

Rijeka, 2016

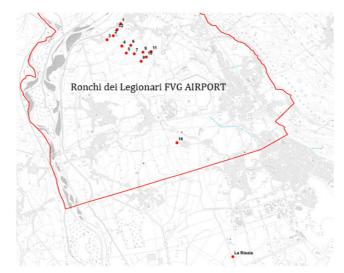
Figure 2.1-2. Location of the AcegasApsAmga pumping wells and La Risaia well. At present, of the line South the only exploited well for drinking purposes is the number 16

Nitrate content on AcegasApsAmga pumping wells, within the years, had always quite low concentrations (<15 mg/l) over a legal limit of 50 mg/l. The nitrates trend in well 2 shows a slight increase while remaining below the legal limit.

The higher recorded values of chlorides were found within the limestones at depths exceeding the 200 m. It is known (Petrini et al., 2013) that a fossil marine aquifer is present in the depths in the carbonates. Therefore the high chloride values identified in the northern wells (2 and 6) can be linked to this resource and not to the salt water intrusion. The general sulphates trend is quite constant, slightly increasing within last years for the wells 2 and La Risaia. However, all the values remain below the legal limit.

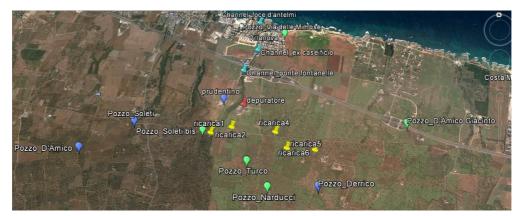
Figure 2.3-2: Sampling locations at the Ostuni test area

During DRINKADRIA activity the partner FB3 has carried out several water sampling in order to monitor groundwater and surface water in the Ostuni test area.

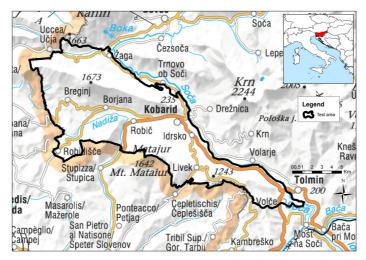
Figure 2.4-1. Geographical location of Kobariški stol, Mia and Matajur aquifers

The test areas of Slovenian project partners are Kobariški stol, Mia and Matajur aquifers, located in NW Slovenia, which are cross-border aquifers on Slovenia-Italy border. The area belongs to Northern Primorska region. It covers the mountain ranges called Kobariški stol in the north and Mija - Matajur in the south that are extending from the city of Kobarid and village Livek in the east towards the west to the villages of Pradielis and Musi in Italy.

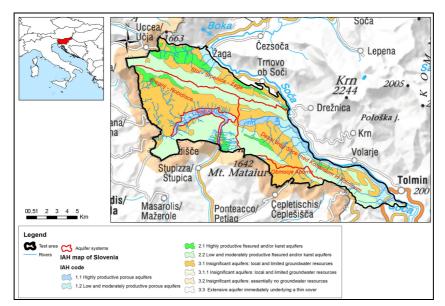
Figure 2.4-2. Hydrogeological map of the test area according to IAH (data from Slovene Environment Agency, 2015)

Carbonates are forming fissured and karst aquifers (Figure 2.4-2). In the valley of Nadiža and Soča river there are small, low productive porous aquifers.

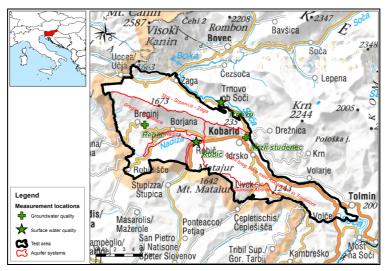
Figure 2.4-3. Locations of water quality measuring points within test area

There are four national monitoring stations for water quality within the investigated area: two for surface water and two for groundwater (Figure 2.4-3).

Monitoring frequency for surface water is 12 times per year and for groundwater twice a year. The number of measurements for statistical analysis in the case of surface water is representative, while the groundwater results due to the small number of measurements were not statistically analysed (Table 2.4-1).

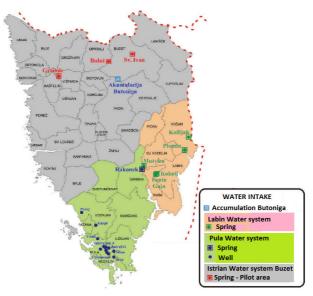
Figure 2.5-1. Monitoring stations for water resources used for water supply in Istrian Region (Zavod za javno zdravstvo Istarske županije, 2014)

The monitoring frequency (number of samples per year) depends on tested water quality parameter, usually from 2 to 13 times per year. But for most of the parameters is 12 times per year according to the program of Croatian Waters.

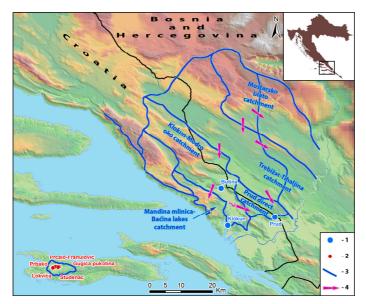
Figure 2.6-1. Locations of the test areas with positions of sampled springs and wells. Legend: 1 Spring, 2 Well, 3 Groundwater divide, 4 Groundwater flow direction.

Test areas represent catchments marked with blue line on Fig.2.6-1.

In addition to Prud, springs in neighboring catchments have been observed and sampled. Results of water quality will be presented for the springs Prud, Klokun and Butina. Among all observed springs, these are selected because they are extracted for water supply. Test area Blatsko polje is located in the most western part of the island Korčula. There are four public extraction sites (wells) used for this part of the Korčula island. Most important well today is Studenac, situated in eastern part of polje close to estavelle Mali Studenac. Other wells are called Gugić, Franulović and Prbako. In Blatsko polje, groundwater samples were taken from wells Studenac, Gugić, Prbako and Franulović and spring Lokvica.

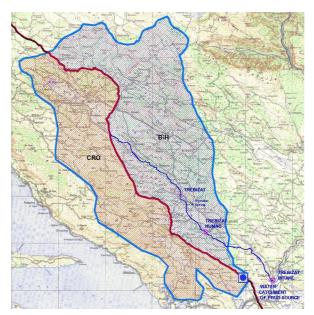
Figure 2.9-1. BiH-Croatia cross - border catchment area Prud and location of water quality monitoring stations on Trebižat river

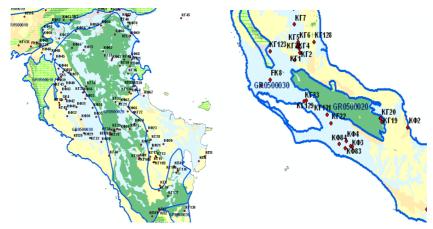
Figure 2.11-4. Points of monitoring of chemical status of the groundwater body GR0500020 (Ministry of enviroment, energy and climate change, 2013)

According to the RBMP (Ministry of environment, energy and climate change, 2013), the Institute of Geology and Mineral Exploration has performed random samplings and chemical analyses in 59 points in 2004-2008, while several Municipal Water and Sewage Enterprises in the island in 2 points (Figure 2.11-4) (Ministry of environment, energy and climate change, 2013).

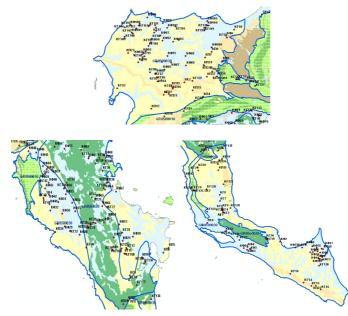
Figure 2.11-5. Points of monitoring of chemical status of the groundwater body GR0500030 (Ministry of enviroment, energy and climate change, 2013)

According to the RBMP (RBMP, 2013; Ministry of enviroment, energy and climate change, 2013), the Institute of Geology and Mineral Exploration has performed random samplings and chemical analyses in 188 points in 2004-2008 (Figure 2.11-5) (Ministry of enviroment, energy and climate change, 2013).
